# FAILURE, ASSESSMENT & DESIGN OF SEWER FORCE MAINS

Webinar

March 3<sup>rd</sup>, 2021

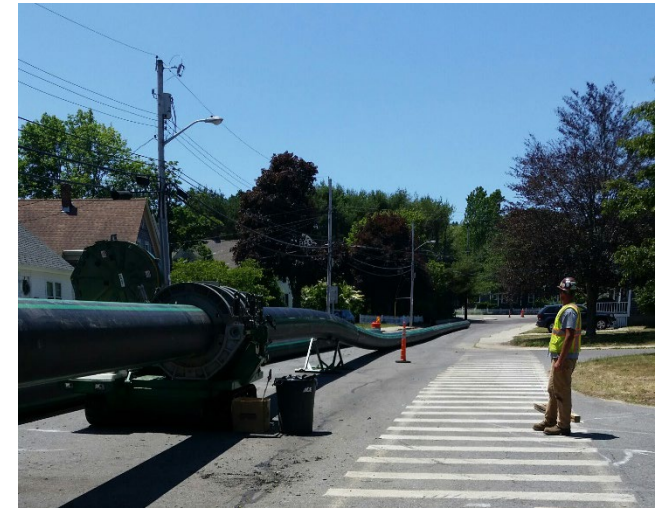
HDPE Force Main For Slip-Lining  
CASE STUDY NO.1

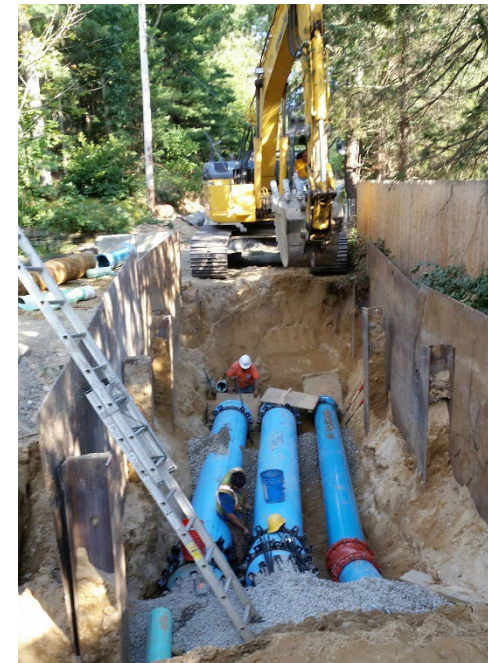
PVC Force Main Installation  
CASE STUDY NO.1

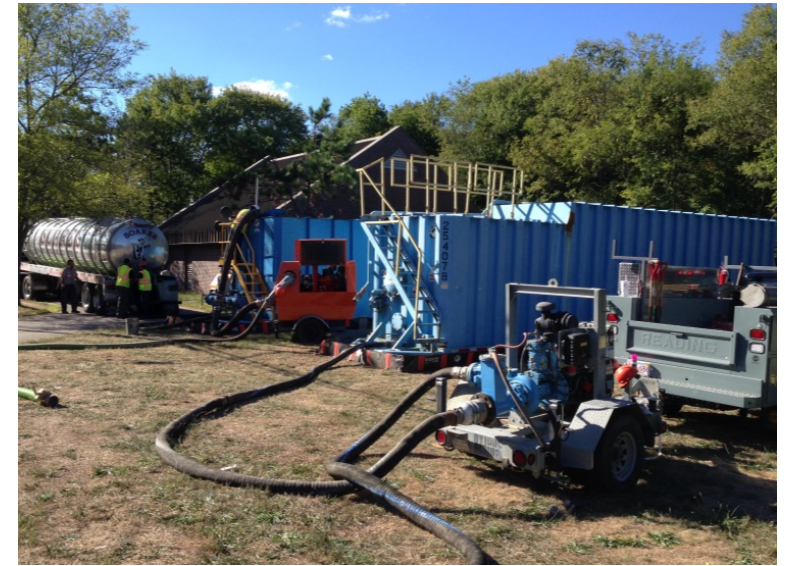
Emergency Response to FM Break

CASE STUDY NO.2

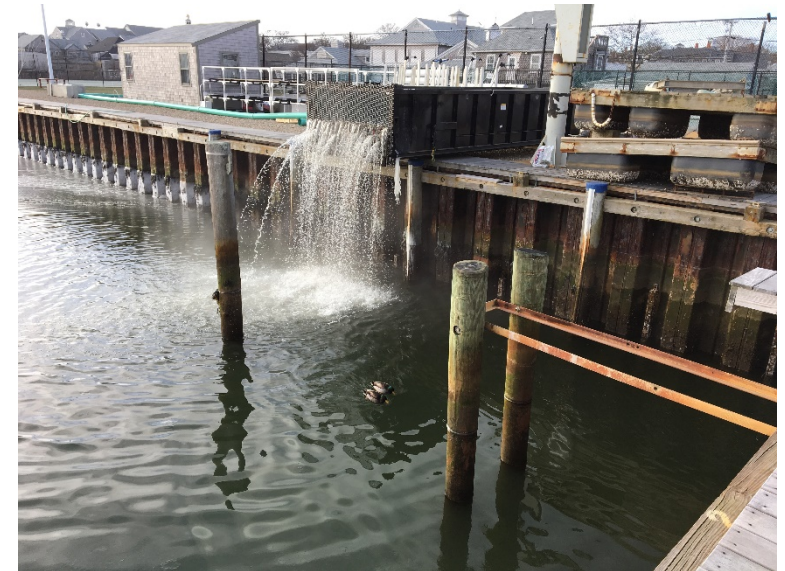
Emergency Response to FM Break

CASE STUDY NO.3

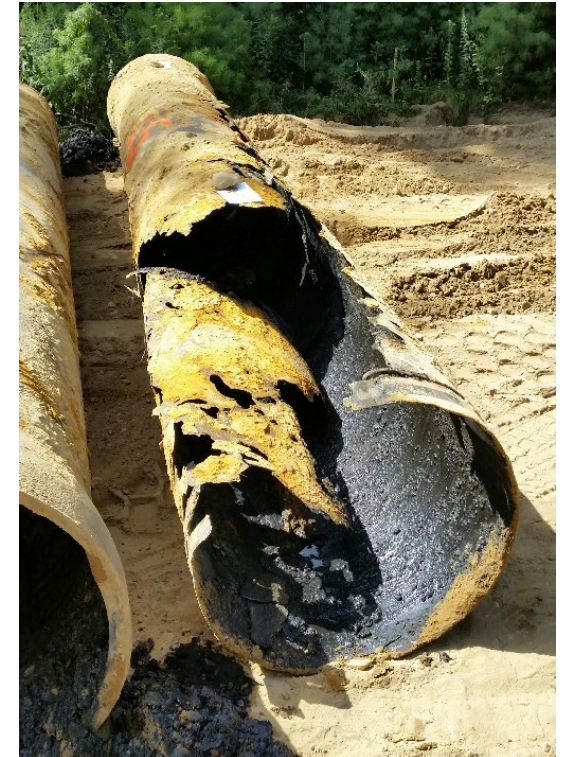
Failed Force Main Section  
CASE STUDY NO.1

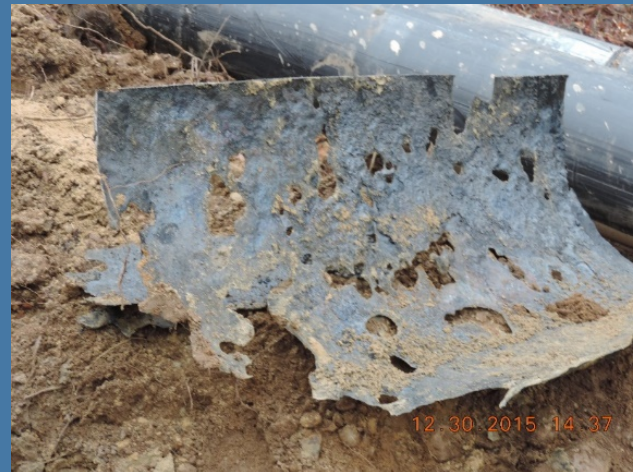
## INTERNAL CORROSION

- $H_2S$  Attack
- Microbial Attack
- Calcium Leaching (Conc. Pipe)
- Abrasion/Scour

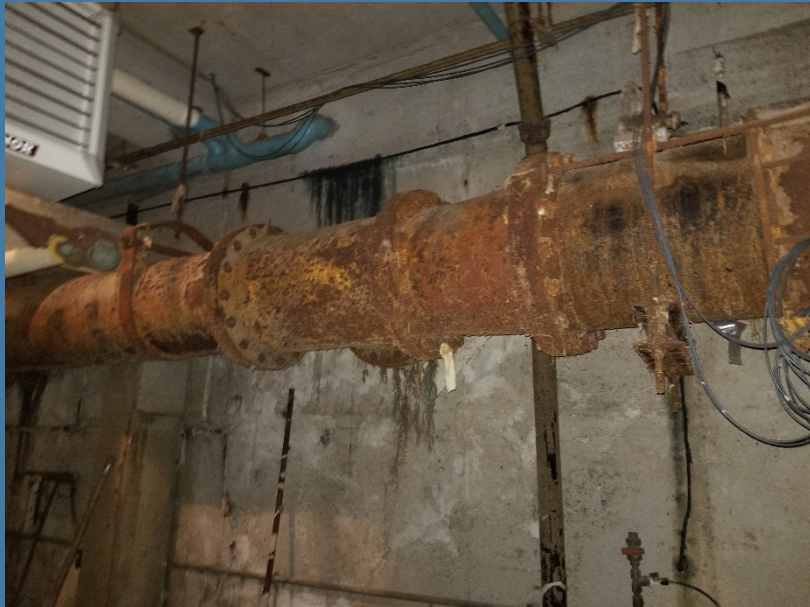
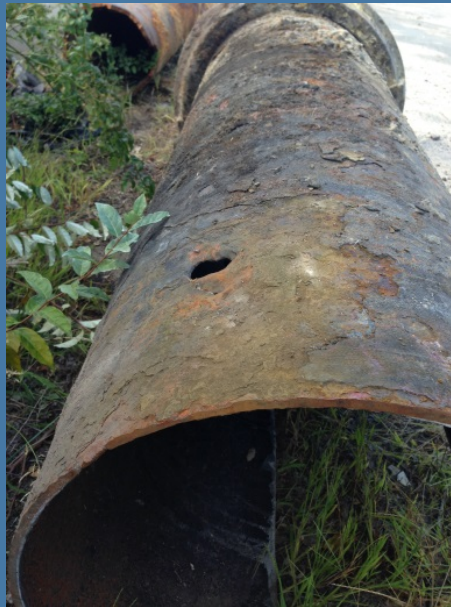
## EXTERNAL CORROSION

- Corrosive Soils
- Loss of Coating
- High Chloride and Sulfate environments
- Damage of ferrous pipe during installation

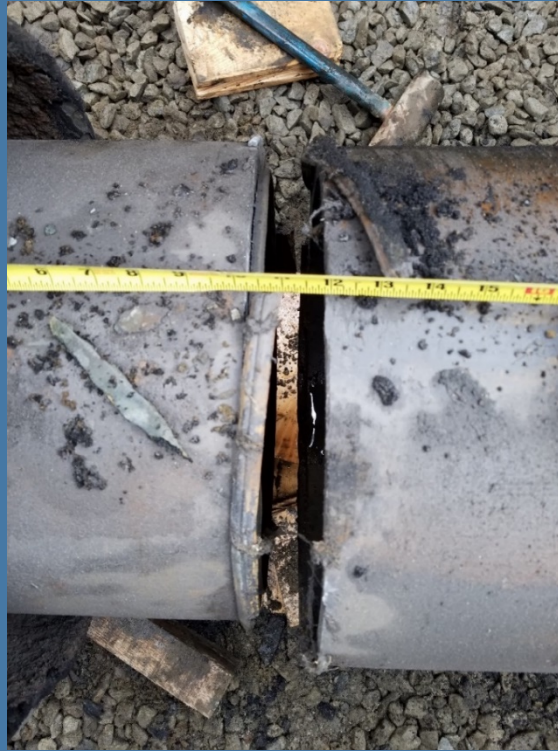
Flexible

- Joint Fusion (HDPE Pipe)
- Pipe Bedding
- Excessive Push (Plastic Pipe)

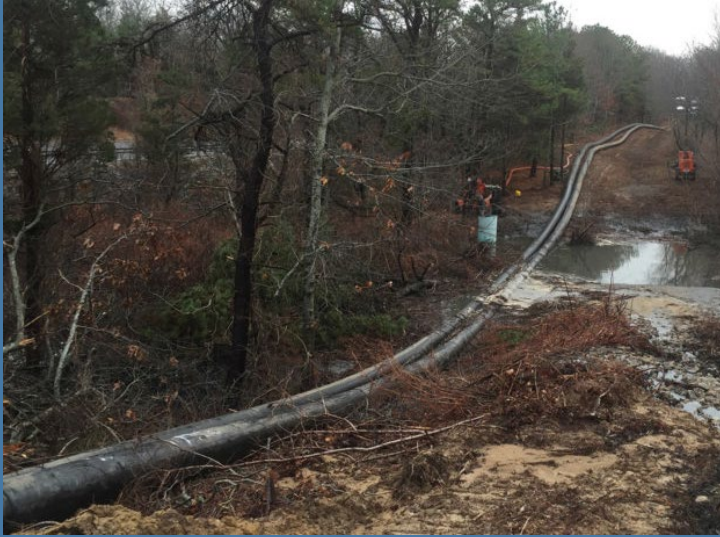
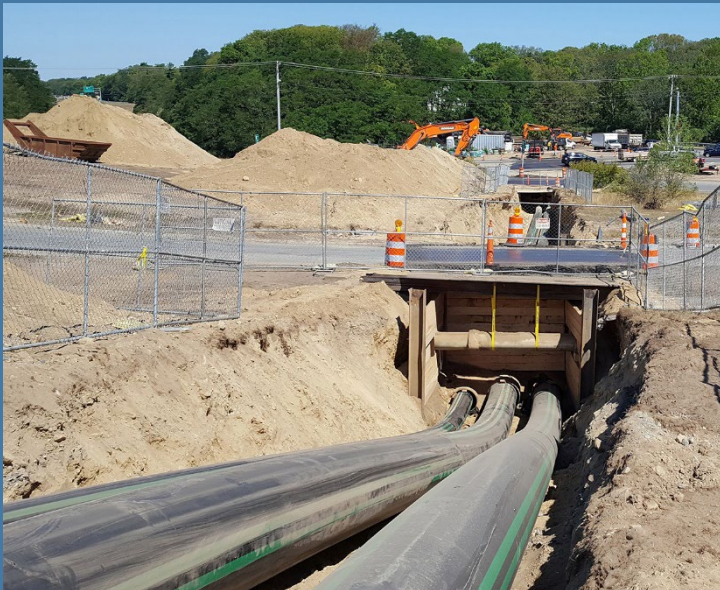
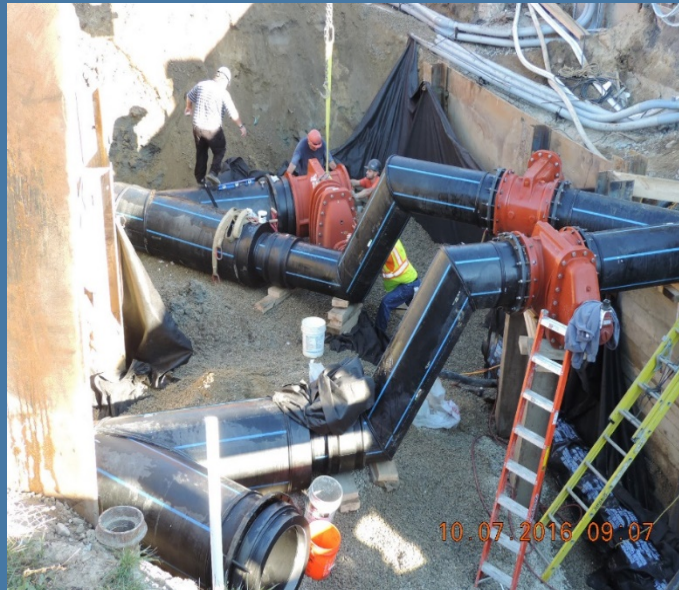
## CASE STUDY NO.1

**Date of Failure(s):** 12/19/2015, 1/27/2016, and 1/31/2016

**Cause of Failure:** H<sub>2</sub>S Corrosion

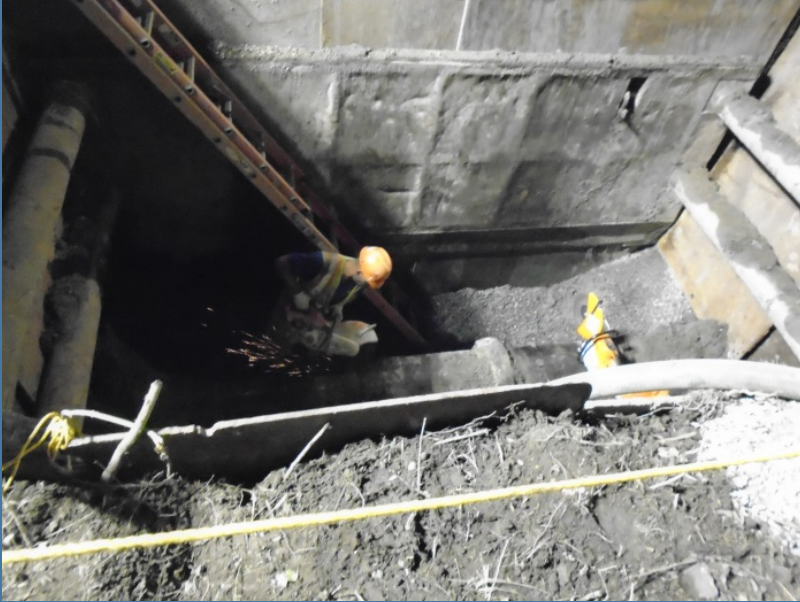
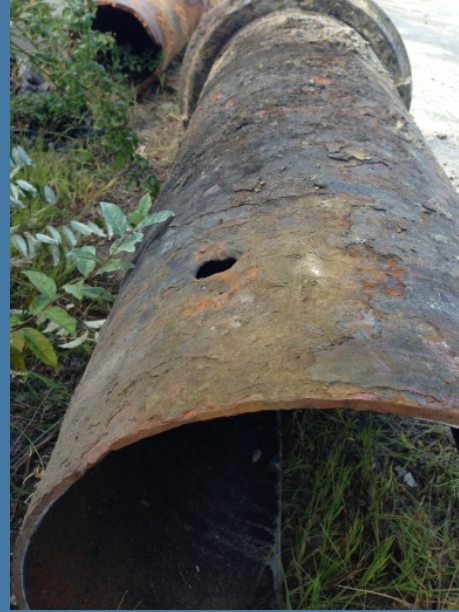
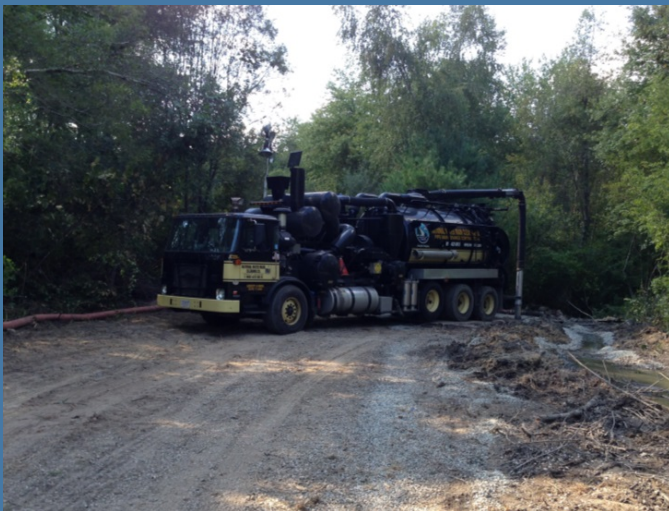
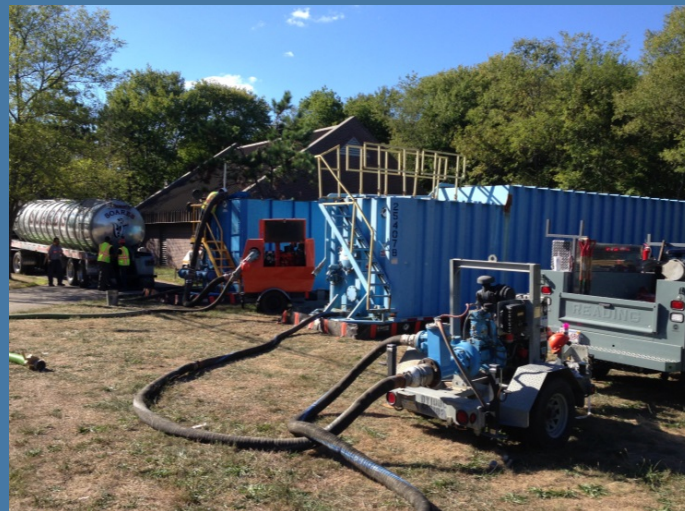
## CASE STUDY NO.2

**Date of Failure(s):** 9/2016 and 10/2017

**Cause of Failure:** Corrosive Soils

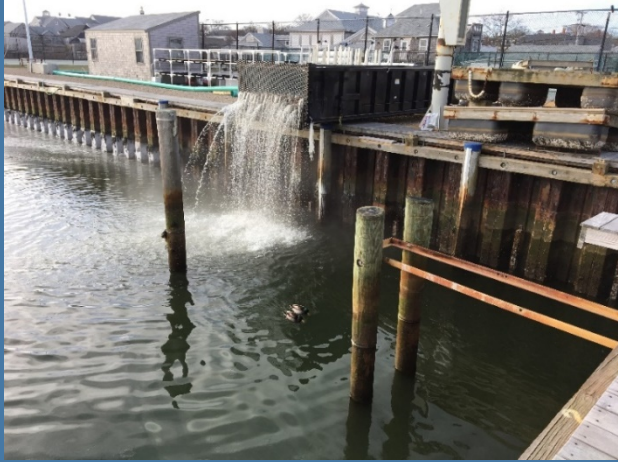
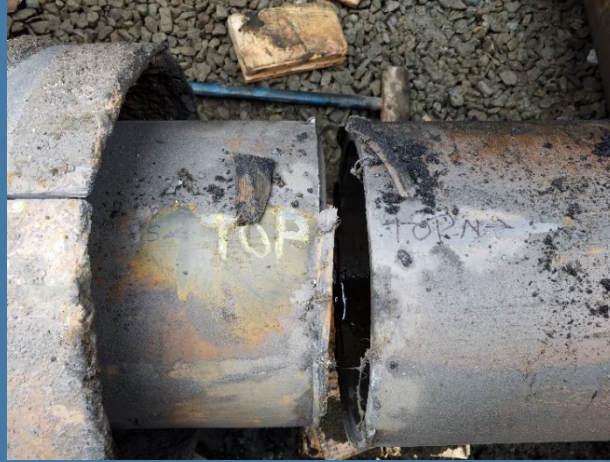
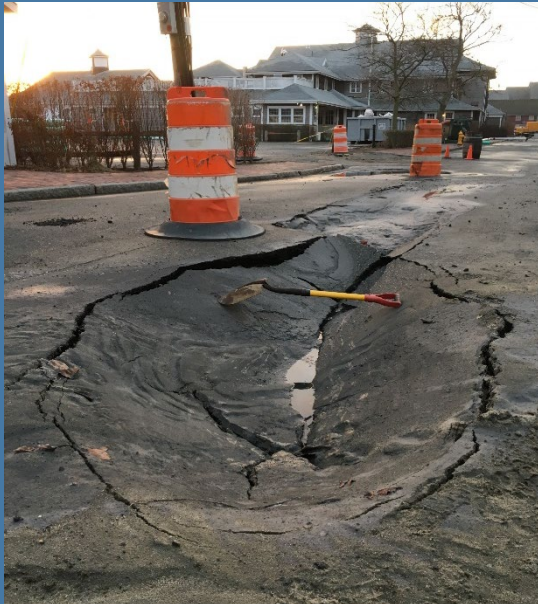
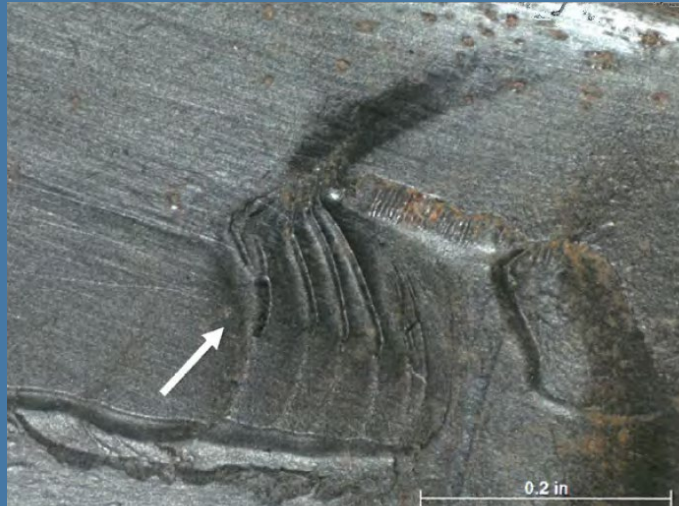
## CASE STUDY NO.3

**Date of Failure(s):** 1/4/2018

**Cause of Failure:** Workmanship Error

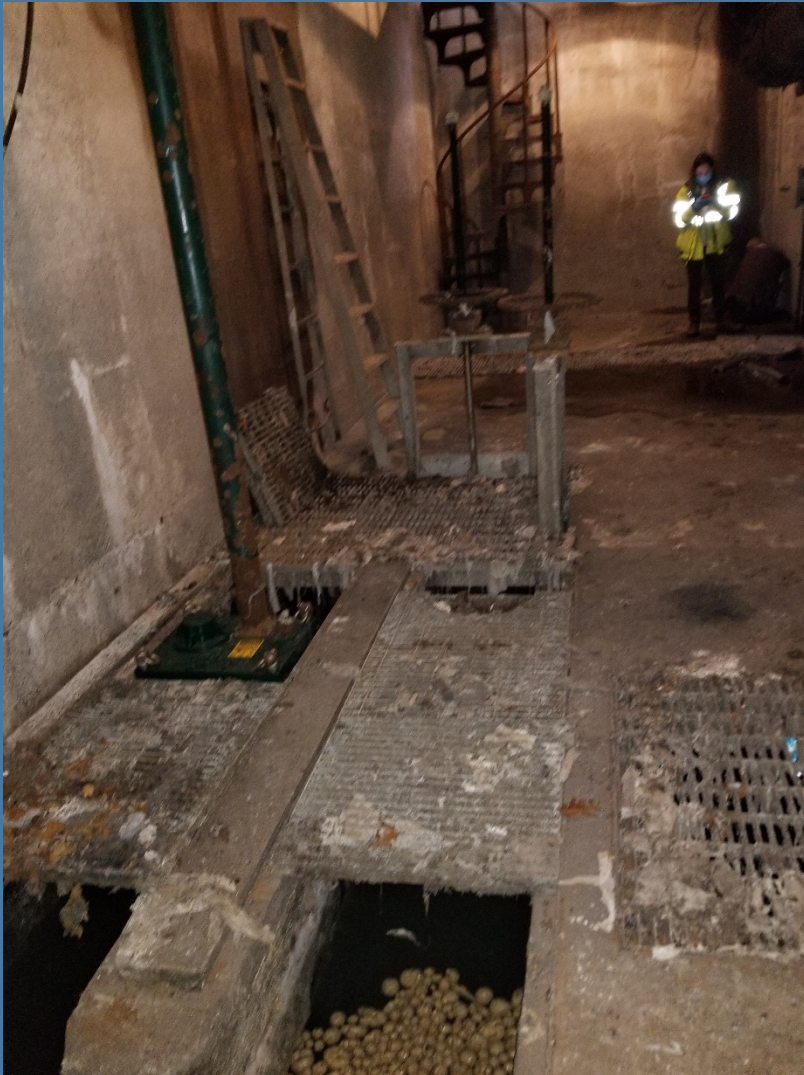
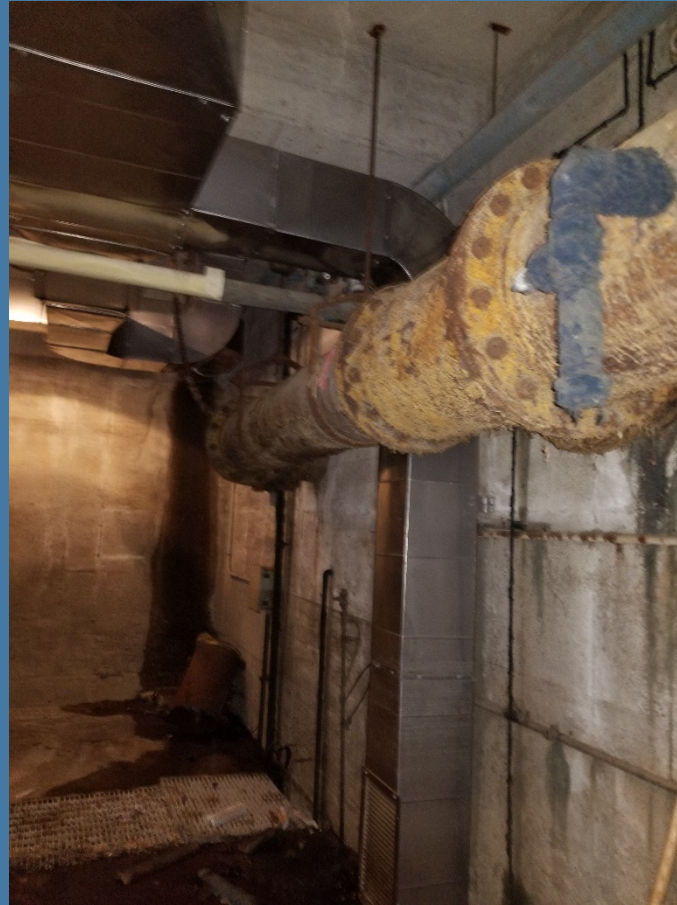
**Unique Features:** Located in wetwell subject to sewer surcharge

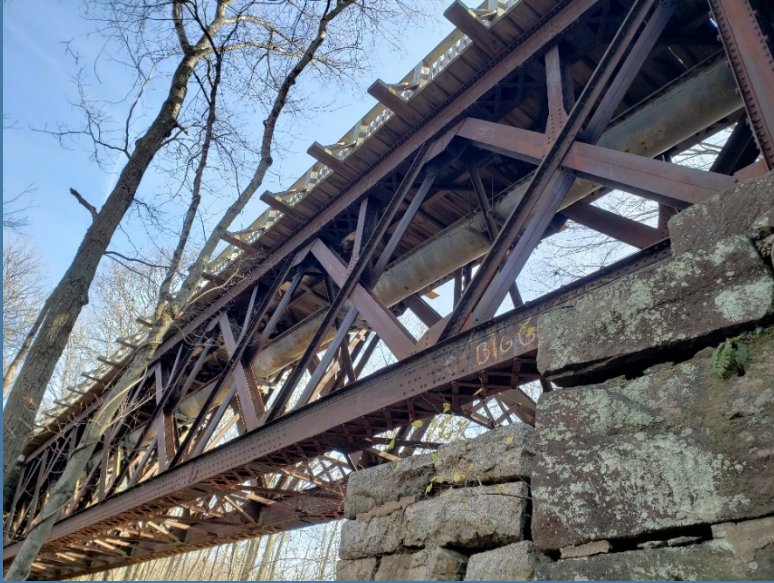
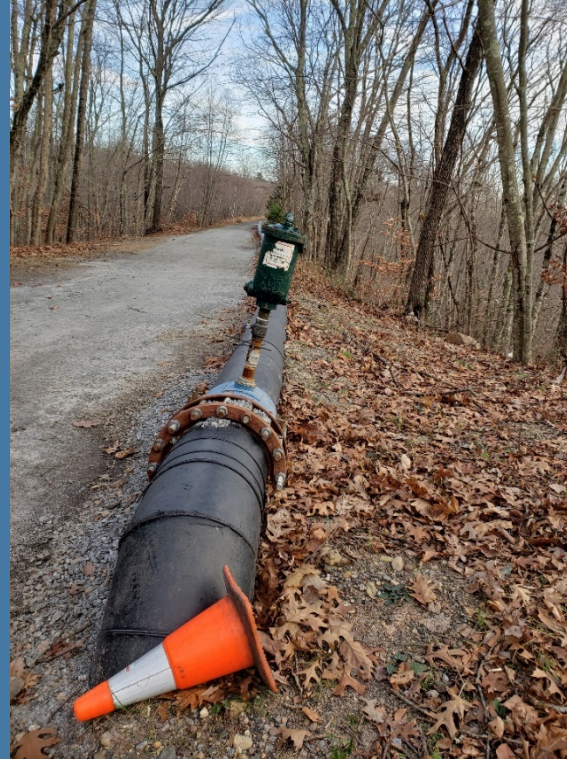
# CASE STUDY NO.5

**Date of Failure(s):** May 2020 (3 breaks)

**Pipe Age:** 1981

**Pipe Size:** 16"

**Pipe Length:** 7.8 Miles

**Pipe Material:** Cement-Lined DI

**Cause of Failure:** Internal Corrosion

**Unique Features:** Length of pipe; easement and exposure

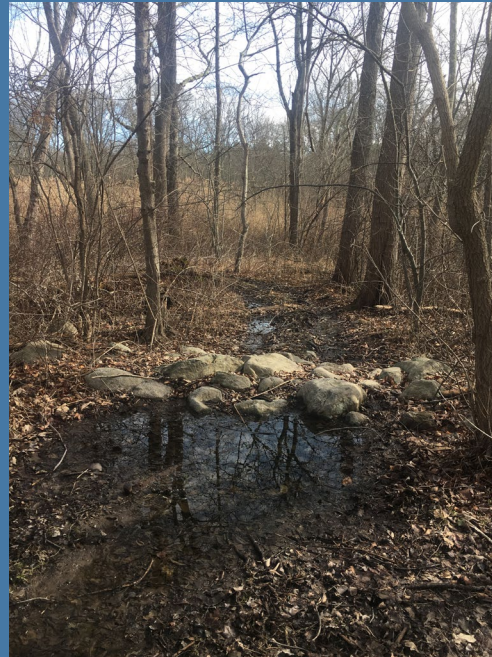
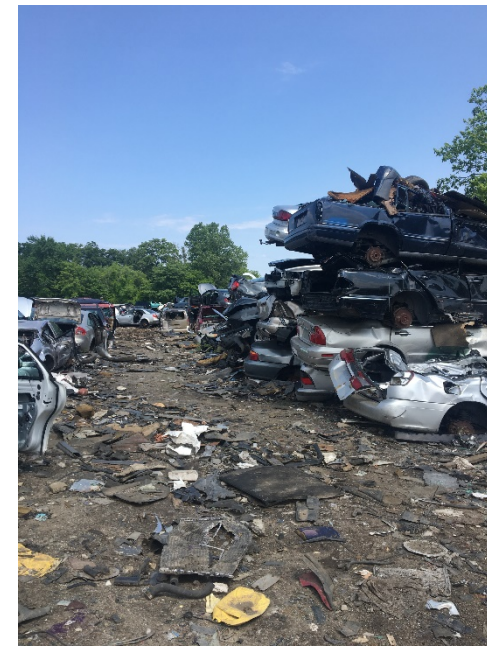
- Conduct Site Visit to relevant areas including Pump Stations and/or Treatment Plants
- Obtain records, operation and maintenance manuals, and pump station data
- Coordinate with Town staff
- Walk the entirety of the force main alignment. Gather notes and note any concerns

Force Main Alignment Walk Through  
CASE STUDY NO.2

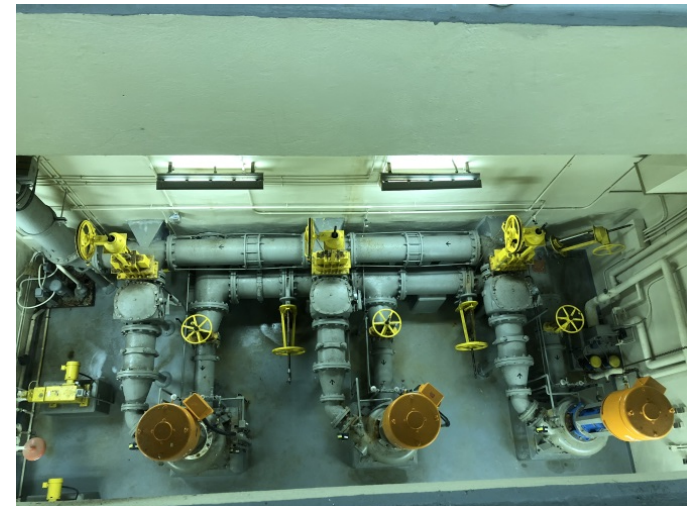
Site Visit to Pump Station  
CASE STUDY NO.2

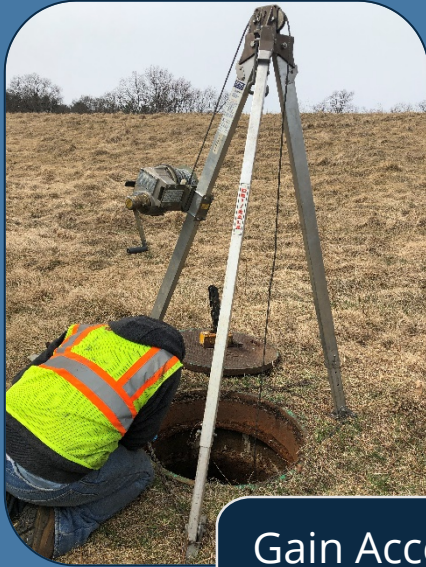
### Gain Access to Force Main

- Via Existing Access Manholes (if present)
- Via Excavated Access Pits

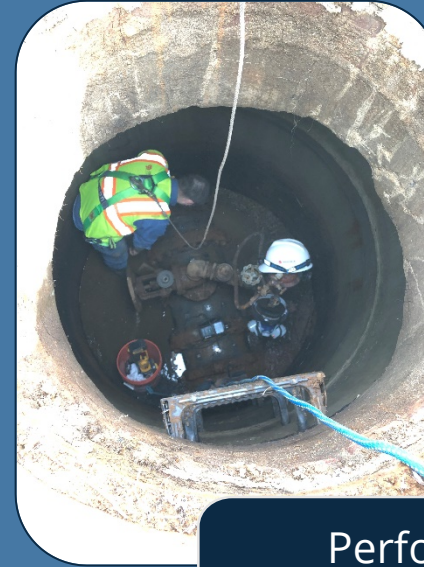
### Perform Exterior Condition Assessment

- Multiple Methods Available

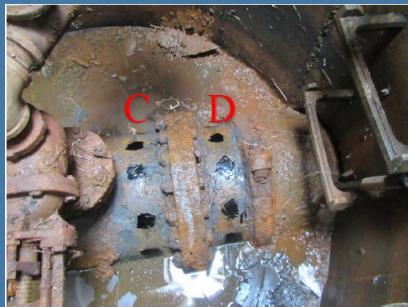
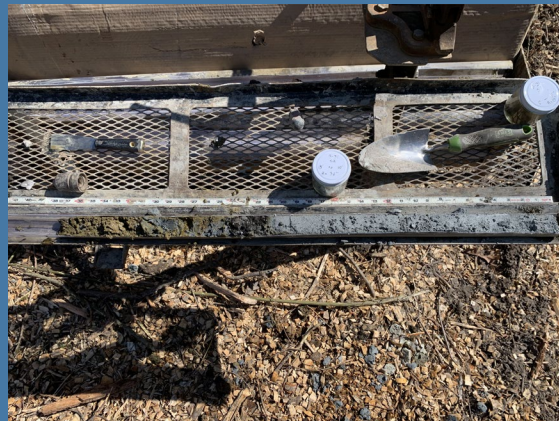
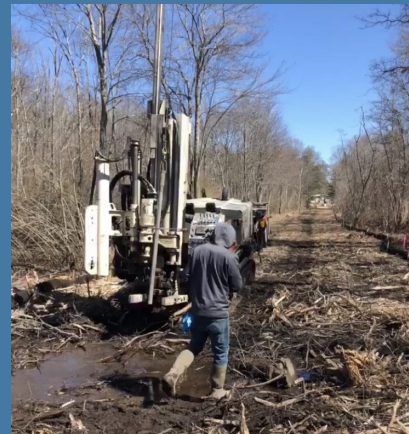
- Ultrasonic Thickness Scan
  - Determine if a loss of wall thickness has occurred in the pipe using a non-destructive, non-invasive method
- Geoprobe/Boring Drilling and Sampling
  - Determine if corrosive soils are present and whether the force main is at risk of external corrosion (AWWA 10-Point System)

### AWWA 10-Point System for Soil Corrosivity CASE STUDY NO.2

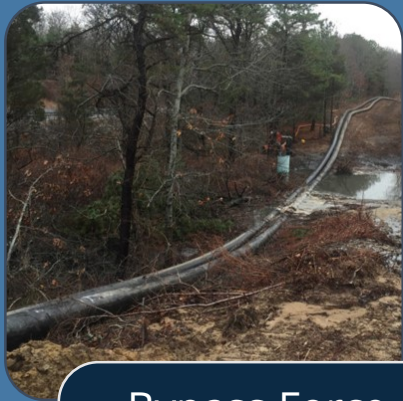
### Bypass Force Main

- Via Existing Standby FM (if present)
- Via Constructed Bypass

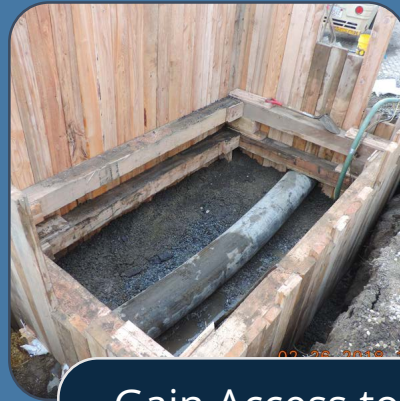
### Gain Access to Force Main

- Via Existing Access Manholes (if present)
- Via Excavated Access Pits

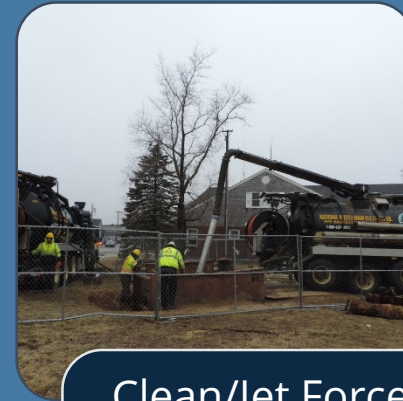
### Clean/Jet Force Main

- Via Existing Access Manholes (if present)
- Via cut and entry into force main

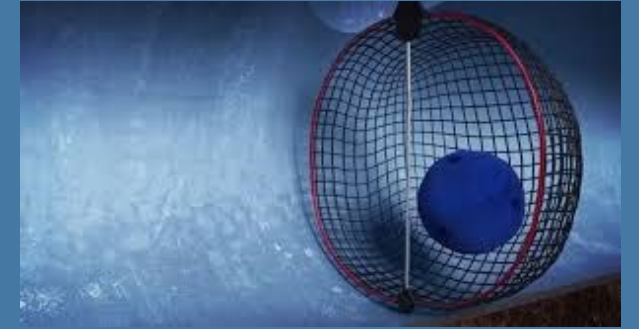
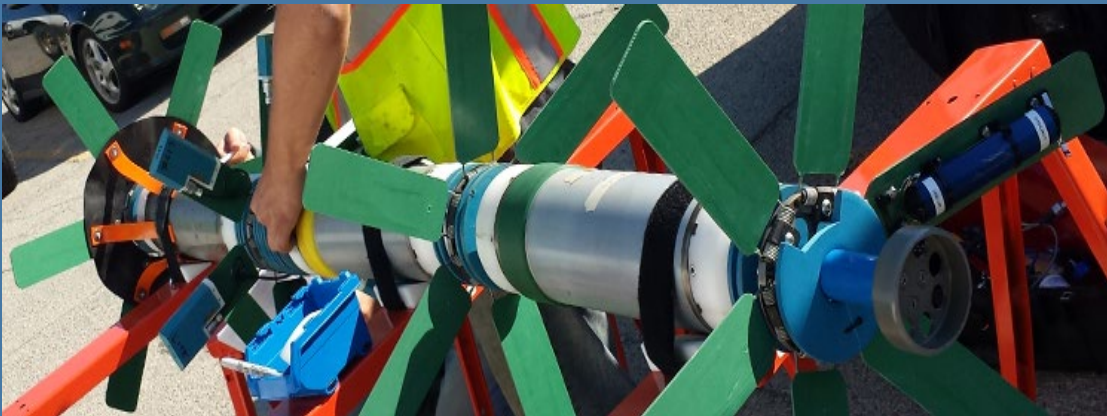
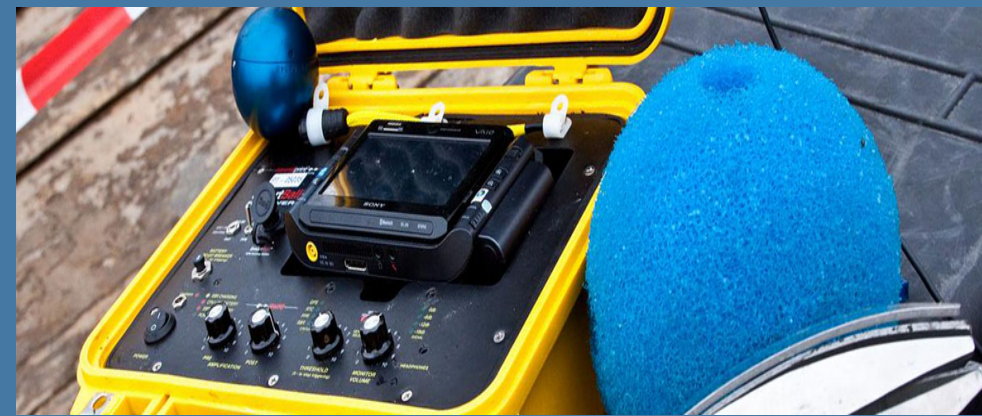
- Smart Ball: Leaks and gas pockets detections
- Pipe Diver: Free swimming tool to locate broken prestressed wires
- Broadband Electromagnetic: Measures wall thickness of exposed pipe
- Ultrasonic Pig: Measures localized wall thickness- Extensive cleaning is required

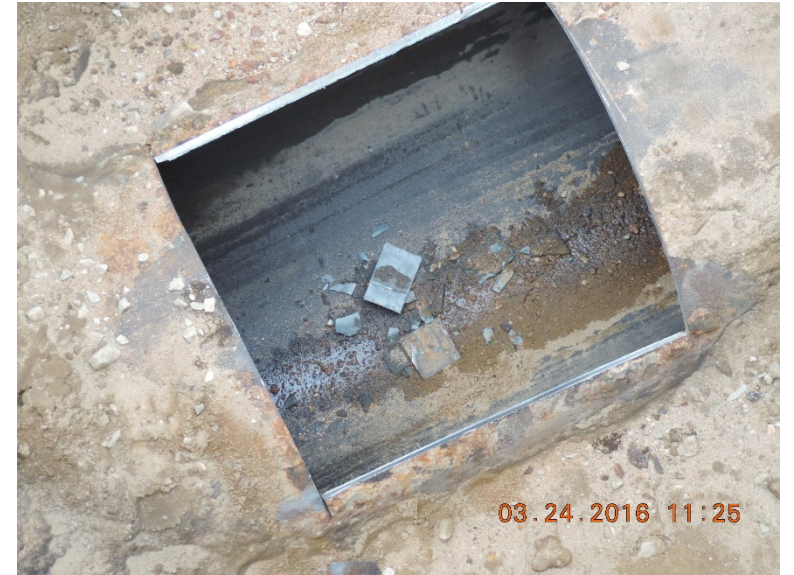
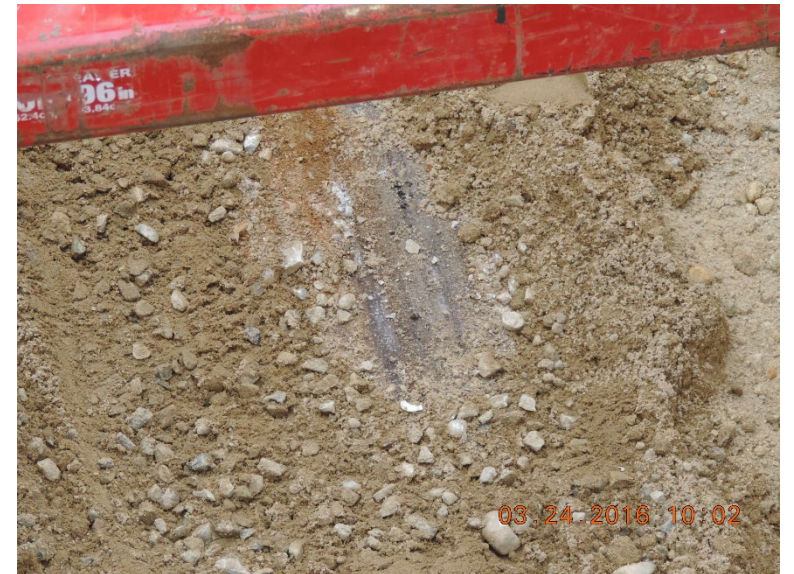
# DESTRUCTIVE TESTING

- Test pits and coupons
- Ultrasonic pigging
- Others

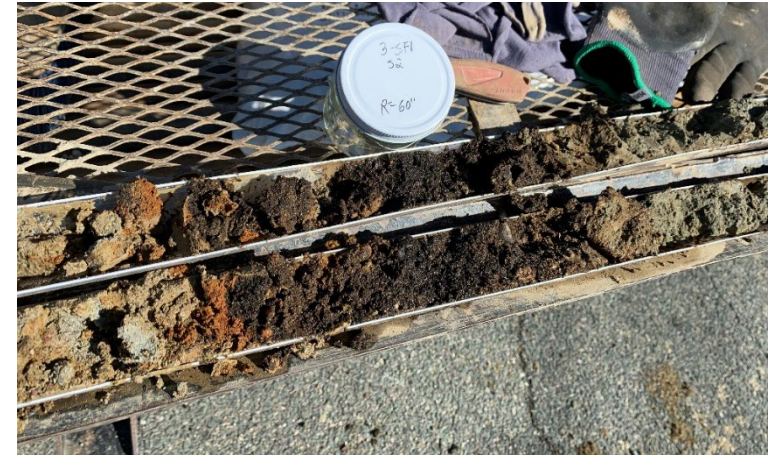
Sampling During Geotechnical Investigation  
CASE STUDY NO.2

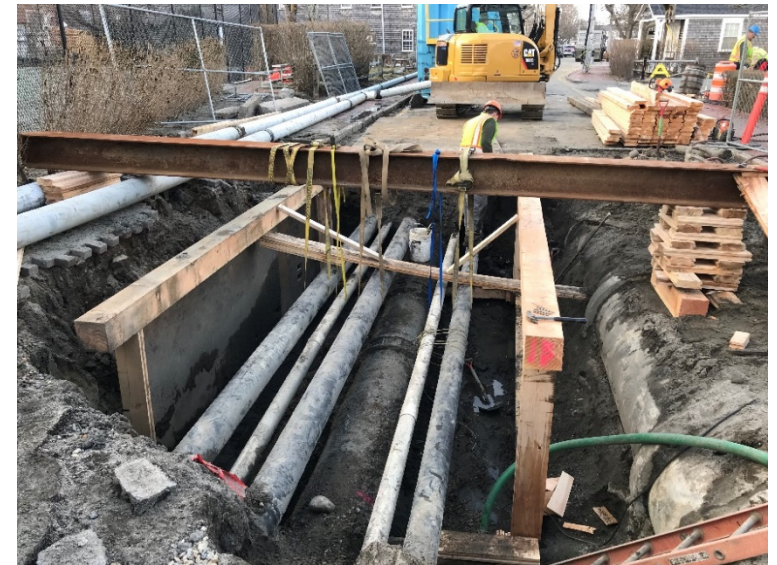
Complex Utility Coordination  
CASE STUDY NO.3
